COUNTRY: UNIDENTIFIED 4 MAY 1966
 SUBJECT: Exploitation of Metallic Fragment from Unidentified Flying Object
 DATE DISR: 4 MAY 66
 NO. PAGES: 2
 REFERENCES: [REDACTED]

On file in CIA Library is an exploitation report on a metallic fragment approximately 2"x2"x1", recovered near Kerekene, Republic of the Congo. The fragment was recovered by ground search after a UFO fell to earth in the area. The report concludes that the fragment was originally part of an electrical component and was constructed of 0.010-inch thick silicon-steel laminate.

FRAGMENT, METAL, RECOVERED IN THE REPUBLIC OF THE CONGO,
GARRIS BELIEVED TO BE AN UNIDENTIFIED FLYING OBJECT
(COUNTRY UNIDENTIFIED) (U)
MCN-25500

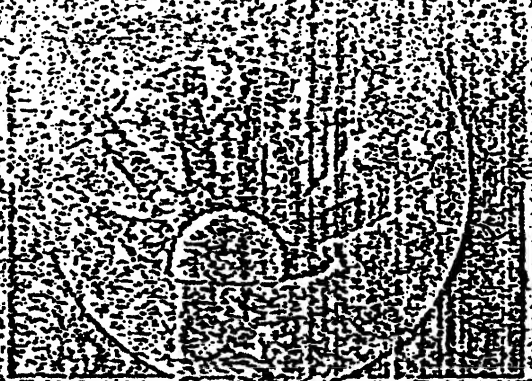
Figure 1. [Illegible text]
March 21, 1964
Kangaroo Island, SA

2. (C) Details concerning the exact location and characteristics of impact are unknown. However, the appearance of the fragment indicated exposure to high temperatures prior to impact. The surface of the specimen had little or no effect on its final condition or appearance. The fragment weighed 4.41g and an immediate density of approximately iron and measured 2.25 x 1.75 x 1.0 inches. The top and side views of the specimen were rounded and appeared to have been shaped by heating and melting. This is illustrated in Figures 1 and 2. The V-shaped groove, visible in Figure 1, is the outline of an insert of steel that differs slightly from the rest of the specimen. Figure 3 shows the side view of the end shown in Figure 1.
